August 1991

Scanning Electron Microscopy of the Effects of Moisture and  
Elevated Temperature on the Fibre/Matrix Bond in CFRP

## DEFENCE RESEARCH AGENCY

Technical Memorandum Mat/Str 1183

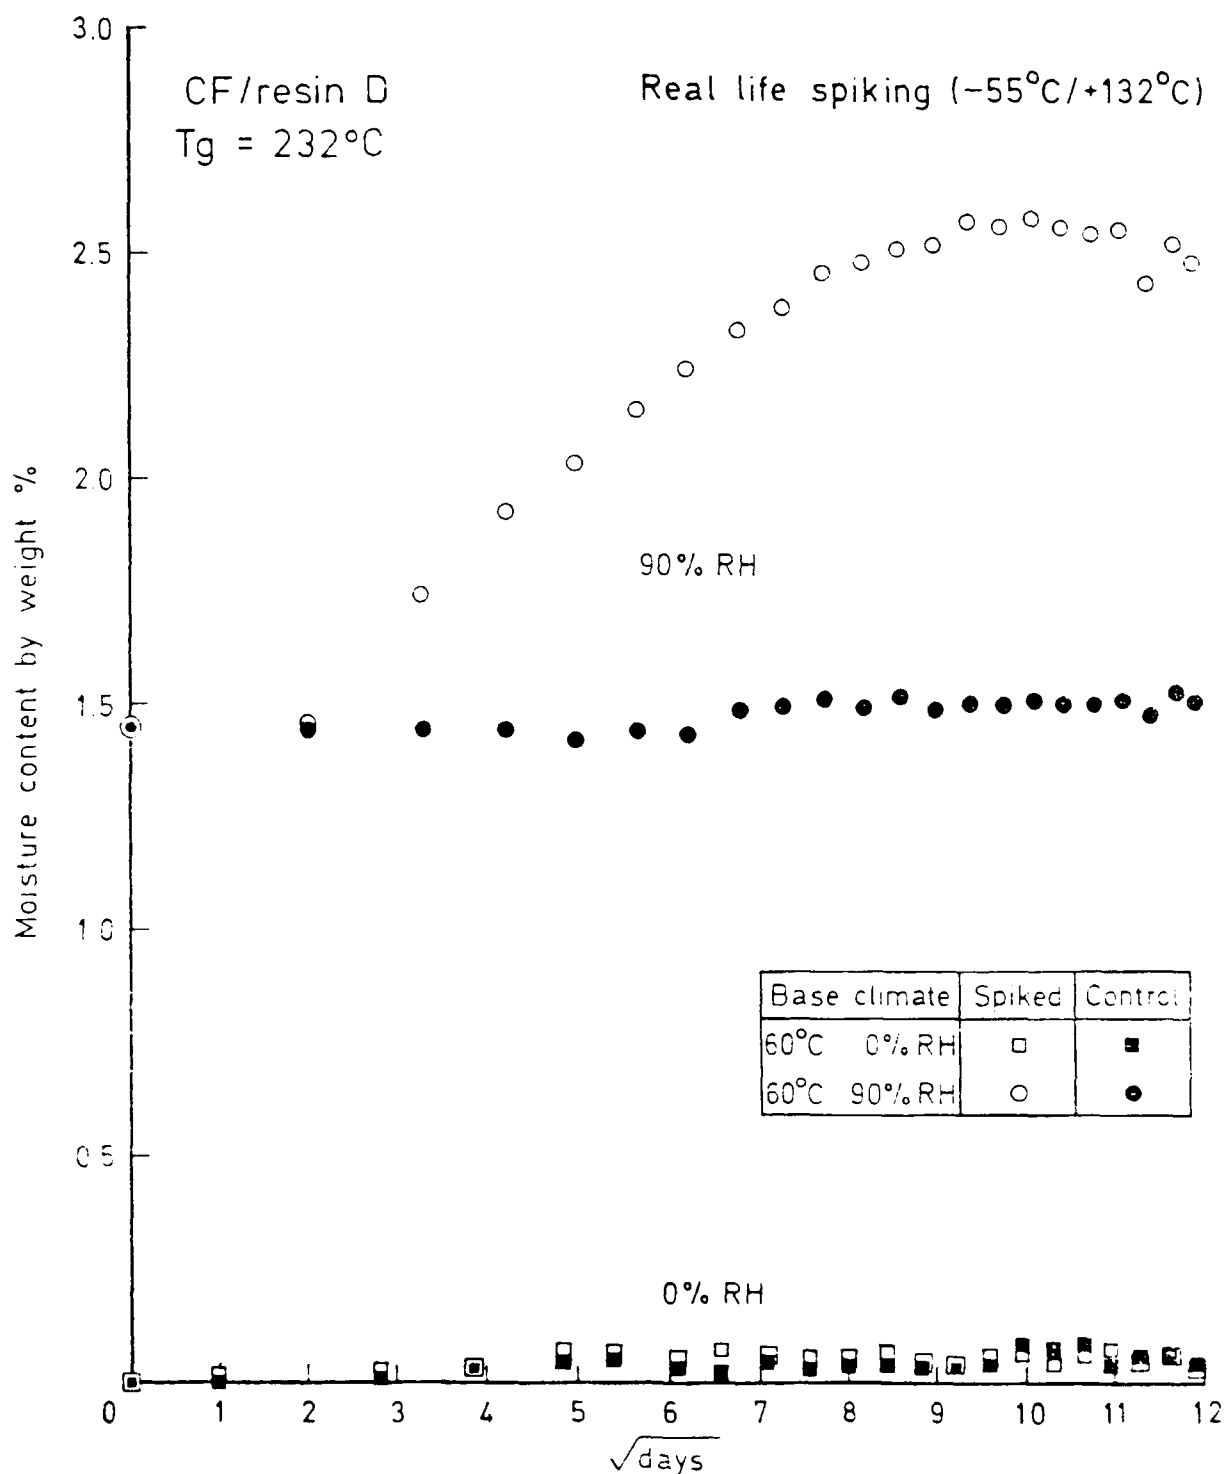
Fig 3

A great deal of work has been carried out to determine the performance of several CF/resin systems conditioned in various environments and subjected to a range of temperature excursions<sup>1&2</sup>. It was found that spikes to +132°C and 'real-life' spikes, consisting of a combination of -55°C for 30 minutes immediately followed by a spike to +132°C, degraded the mechanical properties. Thermal spiking caused a significant increase in moisture absorption in all the materials looked at but was greatest for the CF/resin system investigated here. In a base climate of 75% RH (Fig 2) the moisture contents of spiked specimens were 50% higher than those of the non-spiked controls. It was also found that the increase was greater for base climates with higher humidities. In a base climate of 90% RH the spiked specimens absorbed 70% more moisture than the controls (Fig 3).

Figure 3 Plot of moisture content against root time for specimens real-life spiked compared with non-spiked controls for two extremes of climate.

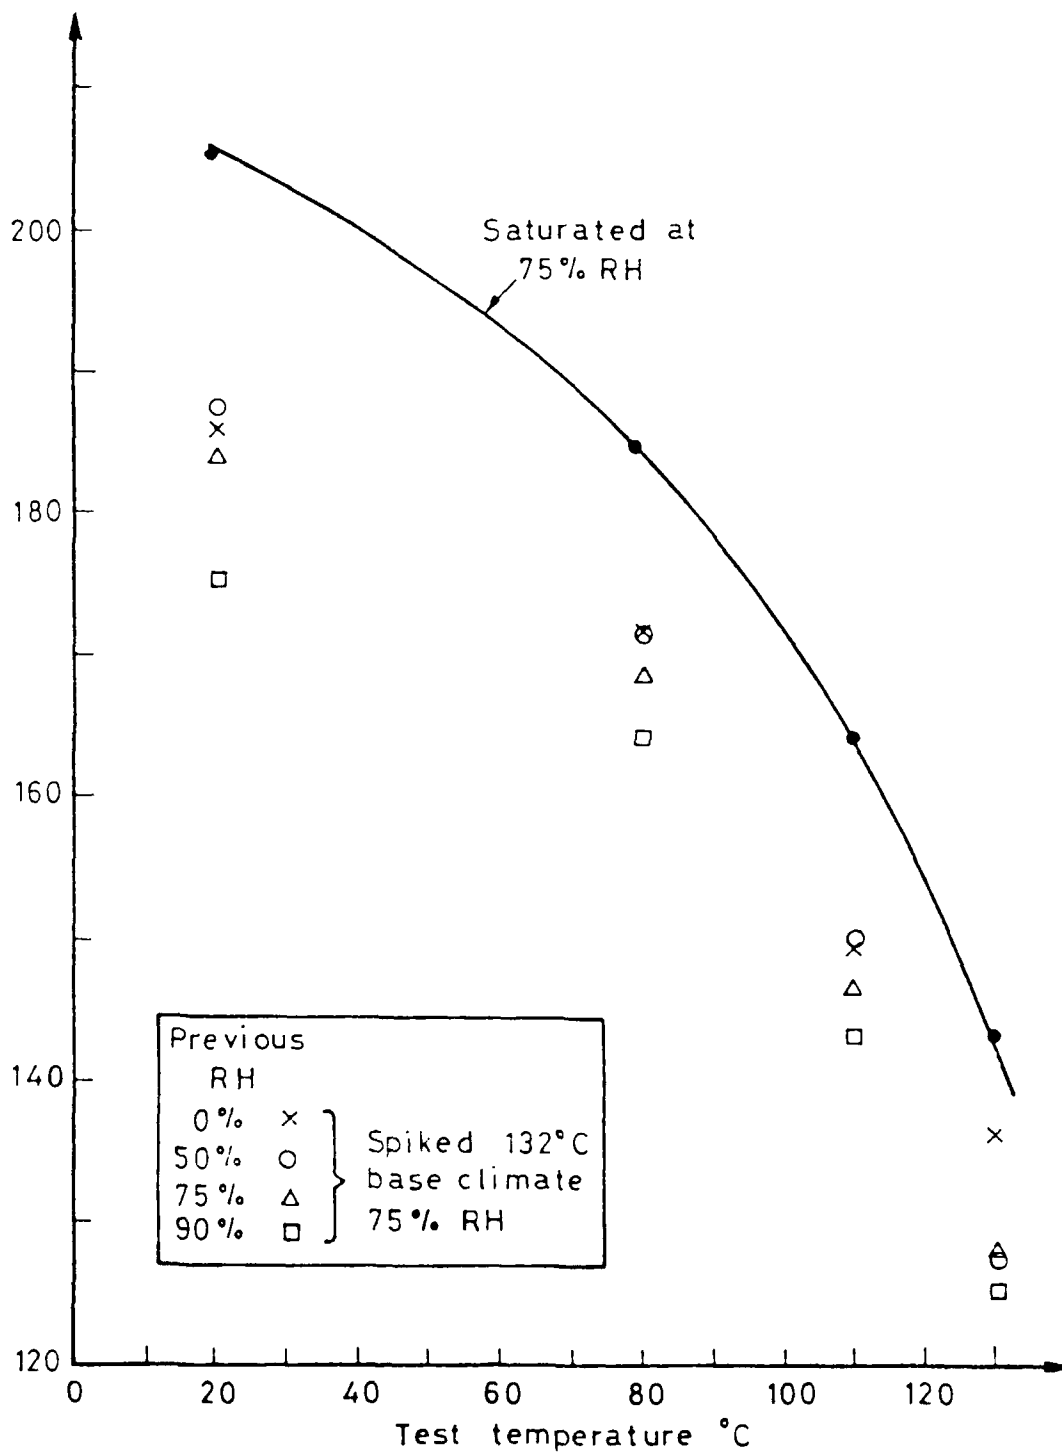
In Fig 6 the failure stresses of the same specimens are shown and in this case the strengths of the spiked specimens are consistently lower than the controls. The extra moisture in the spiked specimens could be present in microcracks in the matrix itself but the visual appearance of tested specimens suggested that the fibre/matrix bond had been degraded and this could cause a drop in tensile strength.

Figure 6 Failure stresses of the specimens described in figure 5.
